# Manhole Inspection Summary

Manhole # S15WW\_023MH

Insp Date: **10/31/08 10:16 AM**

**Location** Address: **REISERTOWN RD**

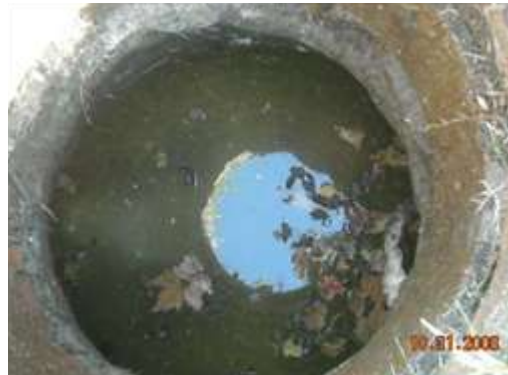
Top View

Active surcharge - Before cleaning.

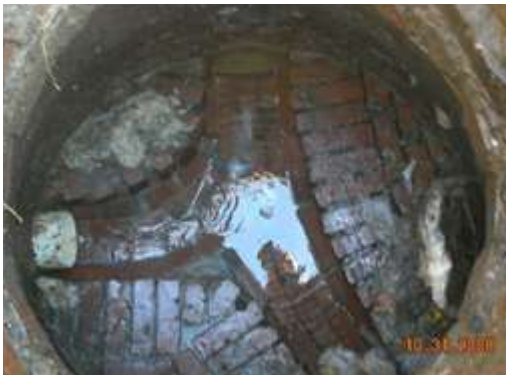
Top View

Corroded steps. Evidence of surcharge - Bench debris.

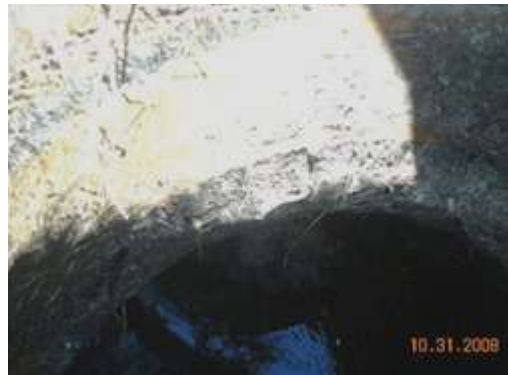
Defect

Frame leaks. Frame offset. Adjustment root intrusion and infiltration.

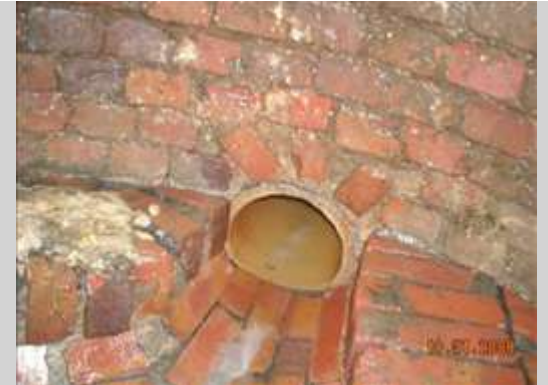
### 8 in. Circular Gravity Sewer Pipe Out @ 12 O'Clock

Infiltration: **Evidence** Pipe Seal Cond: **Unknown**

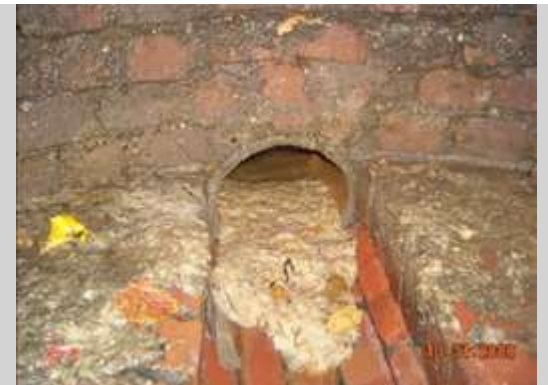
### 8 in. Circular Gravity Sewer Pipe In @ 5 O'Clock

Deposits: ☐ None ☐ Mud ☐ Sludge ☒ **Debris** ☐ Grease

Silt Depth: **3** (in.) Deposits Extent: **Medium**

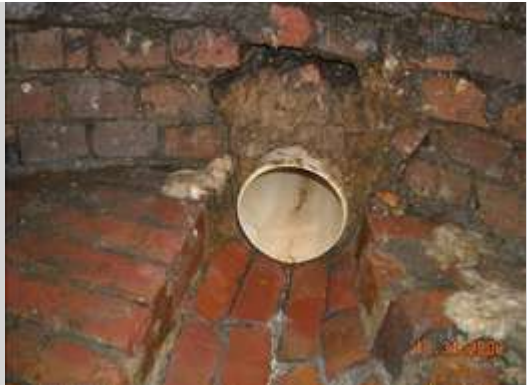
6 in. Circular Gravity Sewer  
Pipe In @ 9 O'Clock

Barrel deterioration and infiltration.
